Kingfisher Fortnightly Bulletin

20th January 2011

Issue 02 / 2011

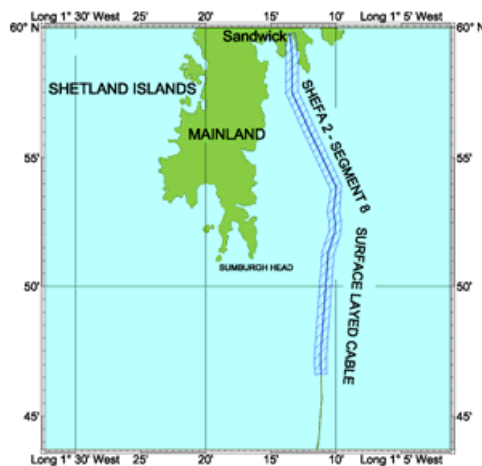
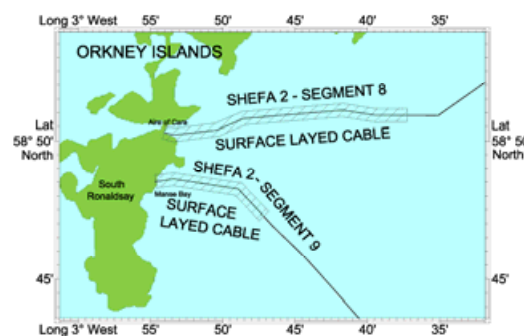
Exposed Cable Sections – SHEFA-2 Segments 8 & 9 (New Entry 08-01-2009)

Please be advised that the shore end sections of the SHEFA-2 Segment 8 cable have been surface laid for approximately 17 kilometres from the Orkney landing and 26 kilometres from the Shetland landing and therefore represents a hazard to fishing and should be avoided at all times. The Orkney landing of the SHEFA-2 Segment 9 cable has also been surface laid for a distance of approximately 9 kilometres from shore. A part buried section further south along the route also exists.

Please see the charts below for details of the exposed sections and for coordinates of these sections, please see Kingfisher Fortnightly Bulletin – 25 / 2009.

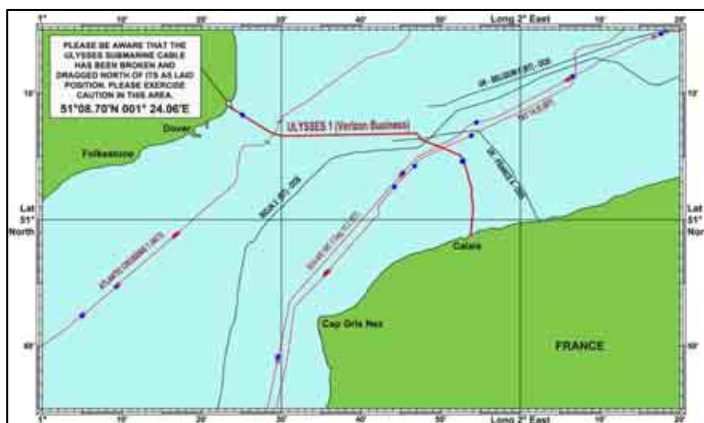
Hazardous Condition of Cable – Ulysses South landing - St Margaret's Bay

Further to earlier Notices, the Ulysses South submarine cable landing at St Margaret's Bay, near Dover, remains broken at a position:

51°08.70'N 01° 24.06'E

This position lies approximately 1.3km offshore in a water depth of 15 metres. As a result of this fault, the cable at the approaches to St Margaret's Bay has been dragged an indeterminate distance to the north of its as laid route on either side of the fault position. Caution should therefore be exercised in this area until the cable repair operation has been carried out.

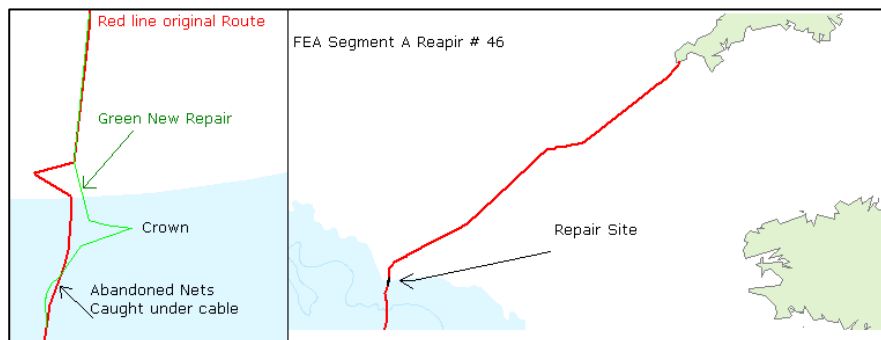
Cable Repair – Hazard to Fishermen (New Entry 30-09-2008)

Following a repair on the Reliance Globalcom FEA Segment A cable at 48°07.3216'N 009°29.7775'W, short lengths of cable within the final bight have not been fully reburied on the steep seabed slopes at this location. The final bight extends out to the East from the cable line from 48°07.3202'N 009°29.8122'W to the crown at 48°07.3202'N 009°29.8145'W - water depth 738.3m.

There are also abandoned fishing nets caught under the re-laid cable which are floating clear of the seabed between 48°06.8080'N 009°30.9012'W and 48°06.8078'N 009°30.9008'W - water depth 977.1m. As these two items could constitute a hazard to fishing vessels bottom trawling we would request that all fishing vessels give this area a wide berth.

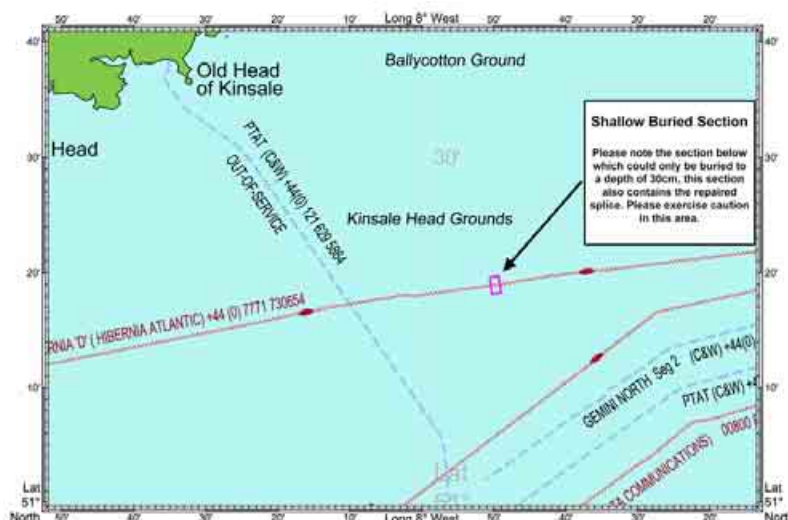
Shallow Buried Section

Shallow Burial of Submarine Cable Section – Hibernia 'D' (New Entry 25-11-2010)

Following a recent repair to the Hibernia 'D' cable, there was difficulty in reburying the cable to the required depth of 1 metre. Please note the section below which could only be buried to a depth of 30cm, this section also contains the repaired splice. Please exercise caution in this area.

1. 51°18.893'N 007°50.289'W
2. 51°18.903'N 007°50.229'W
3. 51°18.997'N 007°50.127'W
4. 51°18.998'N 007°50.120'W
5. 51°18.927'N 007°50.011'W
6. 51°18.951'N 007°49.641'W
7. 51°18.974'N 007°49.336'W

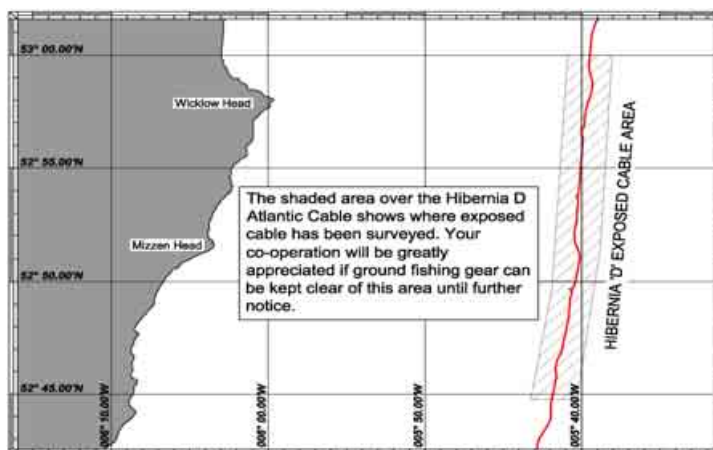
Exposed Submarine Cable Section – Hibernia 'D'

Please note that the Hibernia 'D' cable has been surveyed and has an exposed section. This is indicated in the map below.

The exposed section runs from 52° 59.433' N 05° 39.540' W to 52° 45.118' N 05° 41.797' W. For full details of the exposed cable route, please refer to Kingfisher Fortnightly Bulletin Issue 24 / 2006.

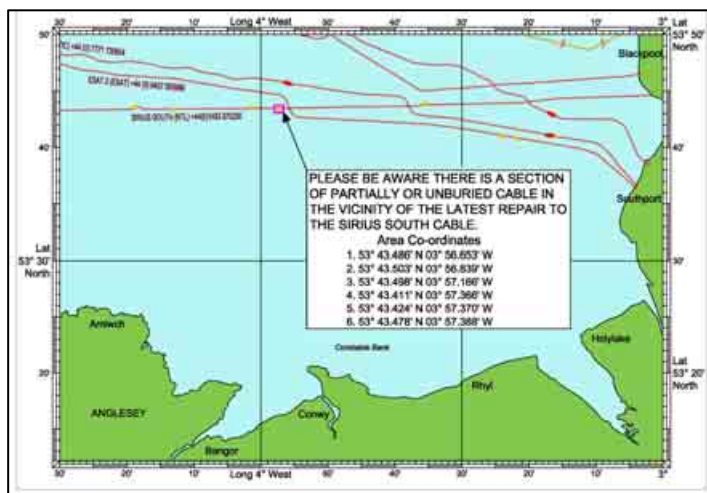
Exposed Submarine Cable Section – Sirius South

Please note that the Sirius South' cable has been repaired and it was found that there is a section of exposed cable in the vicinity of the repair. Please see the map below showing the location of the repair.
