Kingfisher Fortnightly Bulletin

Subsea Cables Subsea Cables Subsea Cables

6th January 2011

Issue 01 / 2011

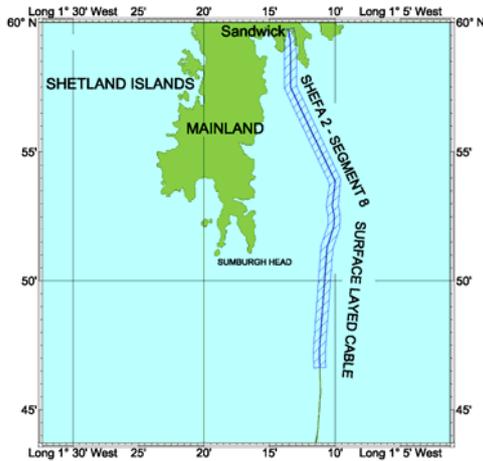
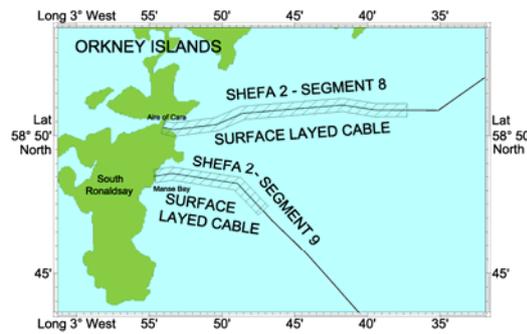
Exposed Cable Sections – SHEFA-2 Segments 8 & 9 (New Entry 08-01-2009)

Please be advised that the shore end sections of the SHEFA-2 Segment 8 cable have been surface laid for approximately 17 kilometres from the Orkney landing and 26 kilometres from the Shetland landing and therefore represents a hazard to fishing and should be avoided at all times. The Orkney landing of the SHEFA-2 Segment 9 cable has also been surface laid for a distance of approximately 9 kilometres from shore. A part buried section further south along the route also exists.

Please see the charts below for details of the exposed sections and for coordinates of these sections, please see Kingfisher Fortnightly Bulletin – 25 / 2009.

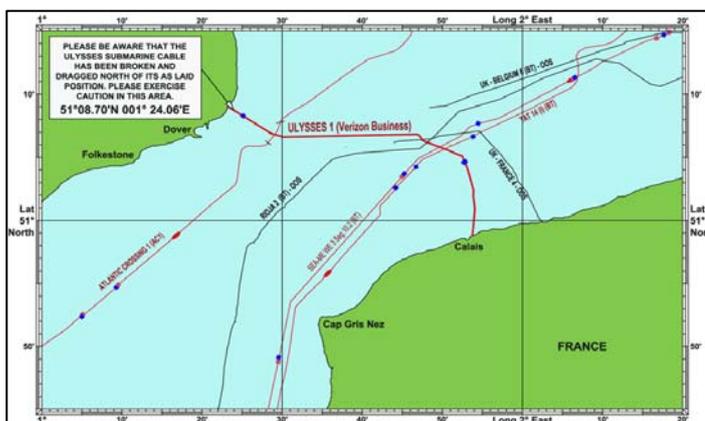
Hazardous Condition of Cable – Ulysses South landing - St Margaret's Bay

Further to earlier Notices, the Ulysses South submarine cable landing at St Margaret's Bay, near Dover, remains broken at a position:

51°08.70'N 01° 24.06'E

This position lies approximately 1.3km offshore in a water depth of 15 metres. As a result of this fault, the cable at the approaches to St Margaret's Bay has been dragged an indeterminate distance to the north of its as laid route on either side of the fault position. Caution should therefore be exercised in this area until the cable repair operation has been carried out.

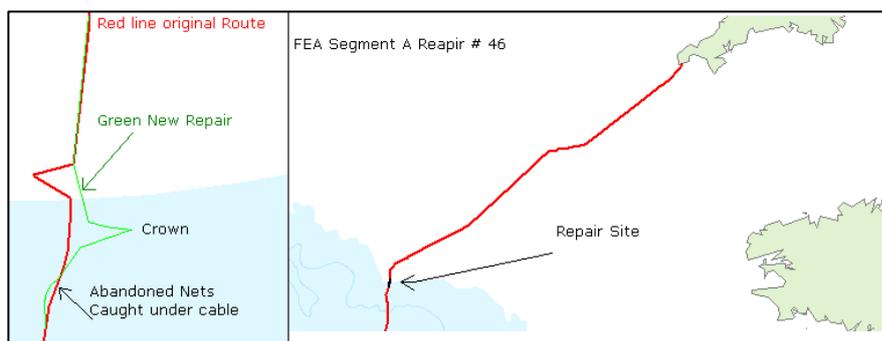
Cable Repair – Hazard to Fishermen (New Entry 30-09-2008)

Following a repair on the Reliance Globalcom FEA Segment A cable at 48°07.3216'N 009°29.7775'W, short lengths of cable within the final bight have not been fully reburied on the steep seabed slopes at this location. The final bight extends out to the East from the cable line from 48°07.3202'N 009°29.8122'W to the crown at 48°07.3202'N 009°29.8145'W - water depth 738.3m.

There are also abandoned fishing nets caught under the re-laid cable which are floating clear of the seabed between 48°06.8080'N 009°30.9012'W and 48°06.8078'N 009°30.9008'W - water depth 977.1m. As these two items could constitute a hazard to fishing vessels bottom trawling we would request that all fishing vessels give this area a wide berth.

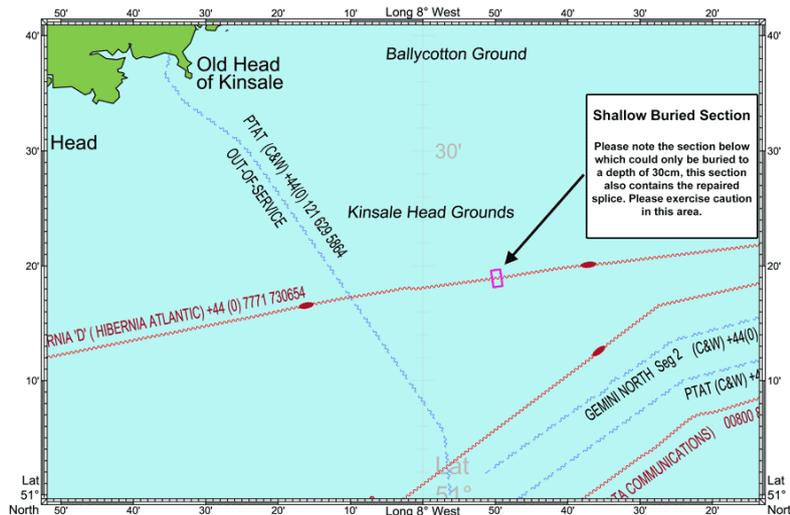
Shallow Burial of Submarine Cable Section – Hibernia ‘D’ (New Entry 25-11-2010)

Following a recent repair to the Hibernia ‘D’ cable, there was difficulty in reburying the cable to the required depth of 1 metre. Please note the section below which could only be buried to a depth of 30cm, this section also contains the repaired splice. Please exercise caution in this area.

Shallow Buried Section

1. 51°18.893'N 007°50.289'W
2. 51°18.903'N 007°50.229'W
3. 51°18.997'N 007°50.127'W
4. 51°18.998'N 007°50.120'W
5. 51°18.927'N 007°50.011'W
6. 51°18.951'N 007°49.641'W
7. 51°18.974'N 007°49.336'W

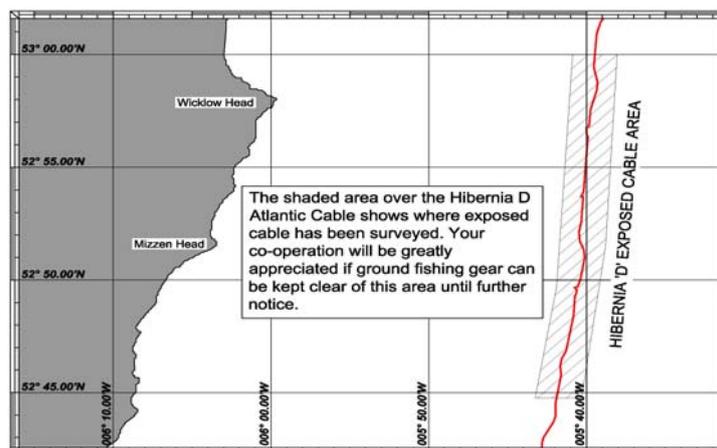
Exposed Submarine Cable Section – Hibernia ‘D’

Please note that the Hibernia ‘D’ cable has been surveyed and has an exposed section. This is indicated in the map below.

The exposed section runs from 52° 59.433' N 05° 39.540' W to 52° 45.118' N 05° 41.797' W. For full details of the exposed cable route, please refer to Kingfisher Fortnightly Bulletin Issue 24 / 2006.

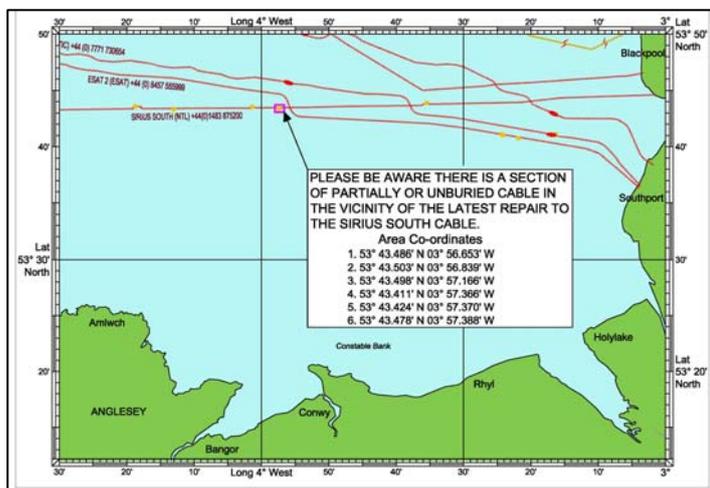
Exposed Submarine Cable Section – Sirius South

Please note that the Sirius South' cable has been repaired and it was found that there is a section of exposed cable in the vicinity of the repair. Please see the map below showing the location of the repair.
