Kingfisher Fortnightly Bulletin

Subsea Cables

25th November 2010

Issue 24 / 2010

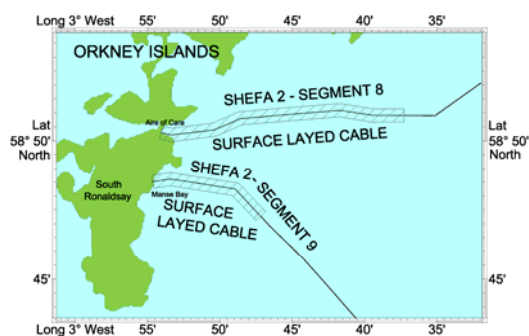
Exposed Cable Sections – SHEFA-2 Segments 8 & 9 (New Entry 08-01-2009)

Please be advised that the shore end sections of the SHEFA-2 Segment 8 cable have been surface laid for approximately 17 kilometres from the Orkney landing and 26 kilometres from the Shetland landing and therefore represents a hazard to fishing and should be avoided at all times. The Orkney landing of the SHEFA-2 Segment 9 cable has also been surface laid for a distance of approximately 9 kilometres from shore. A part buried section further south along the route also exists.

Please see the charts below for details of the exposed sections and for coordinates of these sections, please see Kingfisher Fortnightly Bulletin – 25 / 2009.

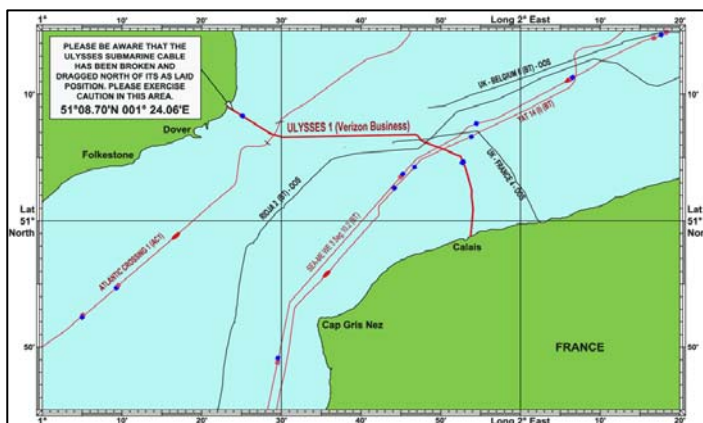
Hazardous Condition of Cable – Ulysses South landing - St Margaret's Bay

Further to earlier Notices, the Ulysses South submarine cable landing at St Margaret's Bay, near Dover, remains broken at a position:

51°08.70'N 01° 24.06'E

This position lies approximately 1.3km offshore in a water depth of 15 metres. As a result of this fault, the cable at the approaches to St Margaret's Bay has been dragged an indeterminate distance to the north of its as laid route on either side of the fault position. Caution should therefore be exercised in this area until the cable repair operation has been carried out.

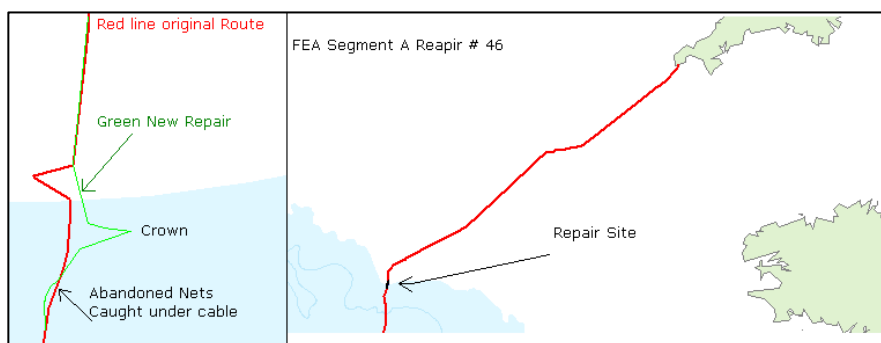
Cable Repair – Hazard to Fishermen (New Entry 30-09-2008)

Following a repair on the Reliance Globalcom FEA Segment A cable at 48°07.3216'N 009°29.7775'W, short lengths of cable within the final bight have not been fully reburied on the steep seabed slopes at this location. The final bight extends out to the East from the cable line from 48°07.3202'N 009°29.8122'W to the crown at 48°07.3202'N 009°29.8145'W - water depth 738.3m.

There are also abandoned fishing nets caught under the re-laid cable which are floating clear of the seabed between 48°06.8080'N 009°30.9012'W and 48°06.8078'N 009°30.9008'W - water depth 977.1m. As these two items could constitute a hazard to fishing vessels bottom trawling we would request that all fishing vessels give this area a wide berth.

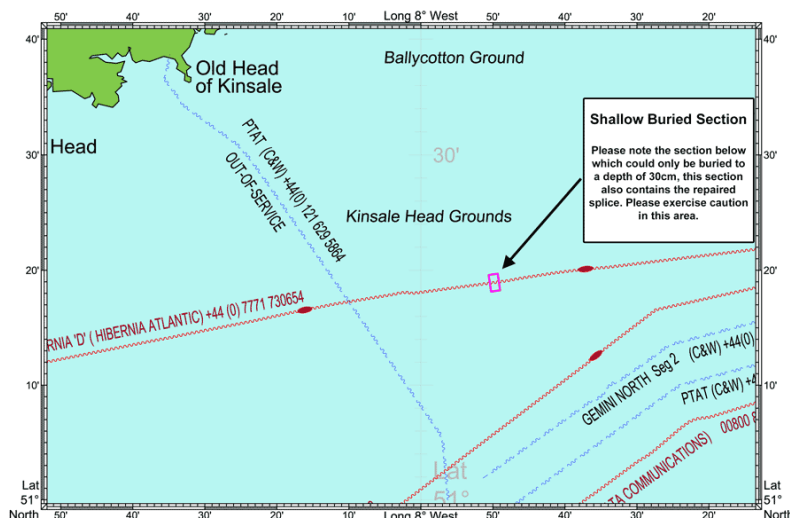
Shallow Buried Section

Shallow Burial of Submarine Cable Section – Hibernia 'D' (New Entry 25-11-2010)

Following a recent repair to the Hibernia 'D' cable, there was difficulty in reburying the cable to the required depth of 1 metre. Please note the section below which could only be buried to a depth of 30cm, this section also contains the repaired splice. Please exercise caution in this area.

1. 51°18.893'N 007°50.289'W
2. 51°18.903'N 007°50.229'W
3. 51°18.997'N 007°50.127'W
4. 51°18.998'N 007°50.120'W
5. 51°18.927'N 007°50.011'W
6. 51°18.951'N 007°49.641'W
7. 51°18.974'N 007°49.336'W

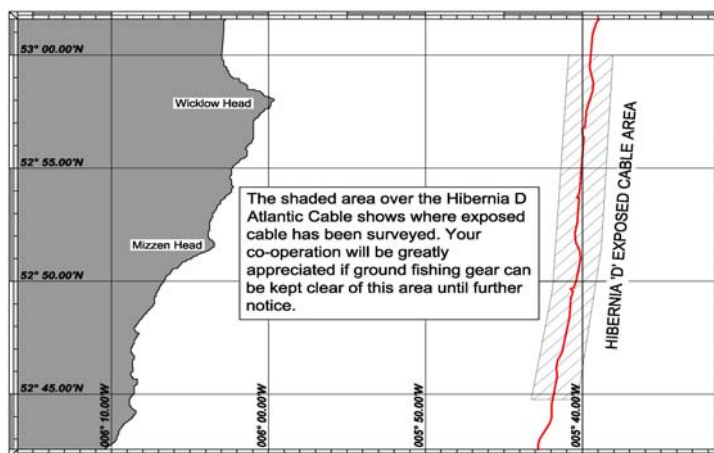
Exposed Submarine Cable Section – Hibernia 'D'

Please note that the Hibernia 'D' cable has been surveyed and has an exposed section. This is indicated in the map below.

The exposed section runs from 52° 59.433' N 05° 39.540' W to 52° 45.118' N 05° 41.797' W. **For full details of the exposed cable route, please refer to Kingfisher Fortnightly Bulletin Issue 24 / 2006.**

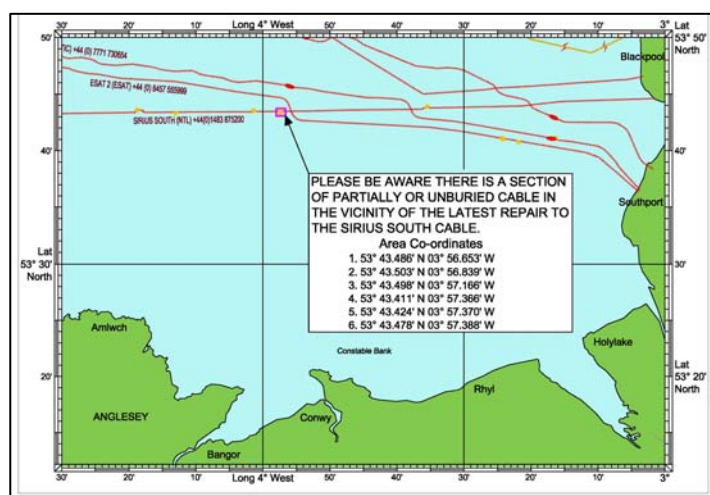
Exposed Submarine Cable Section – Sirius South

Please note that the Sirius South' cable has been repaired and it was found that there is a section of exposed cable in the vicinity of the repair. Please see the map below showing the location of the repair.
