**September 2005**

**Financial Instrument for Fisheries Guidance (FIFG): FEP 686A**

**Trial of acoustic deterrents ('porpoise pingers') for prevention of porpoise (*Phocoena phocoena*) bycatch.**

## **Phase 2 and 3 Endurance and Tangle net Trial**

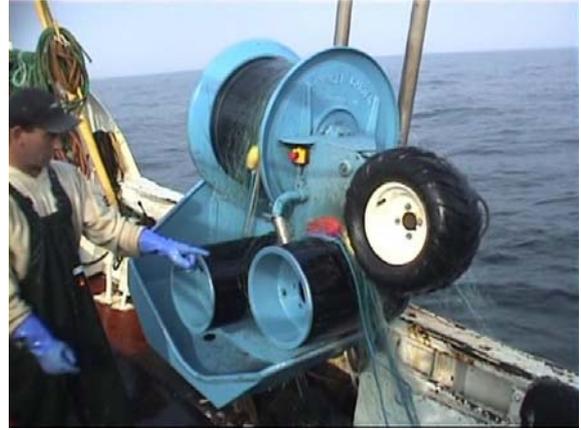
Spencer Carter™ hauler

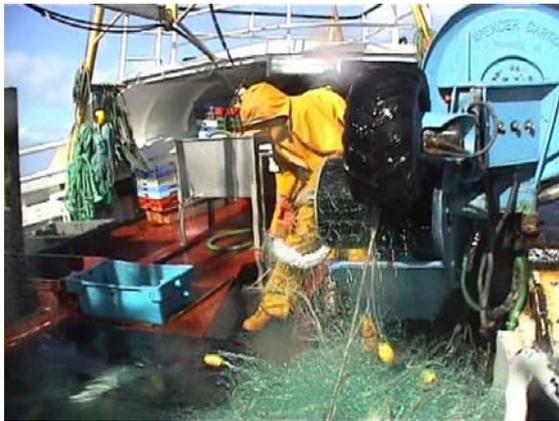
Hauling the gear

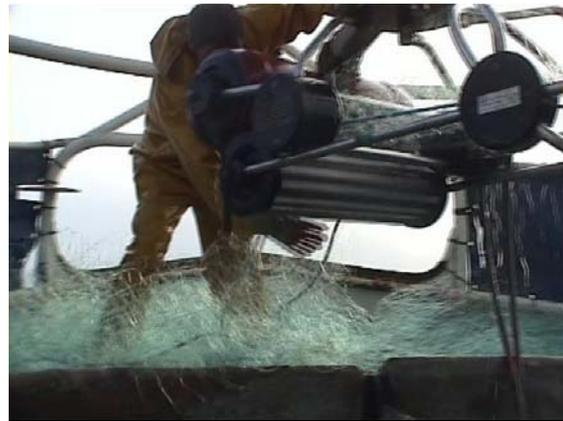
Over ending machine

the nets are over-ended is to remove any twists in the net and separate the headline from the leadline (footline). Due to the pingers weight the over-ending machine had difficulty coping with the pinger when there was more than half a turn in the net. This resulted in the crewmember having to reset the machine, thus slowing down the hauling process. The weight of the pingers also meant that it was quite hazardous to the crew member in charge of the over-ending machine, as in order to spread the net evenly around the net pound he would find himself at times standing directly below the machine. With the possibility of being struck as the pinger is "spat" out of the over-ending machine. The Skipper noted on one of the unaccompanied trips that an AIRMAR pinger hit one of the crewmembers whilst he was over-ending.

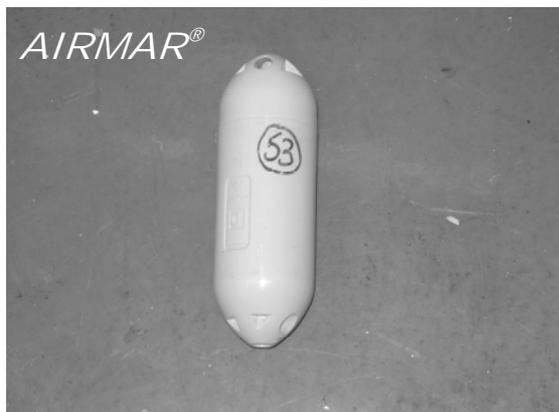
#### AIRMAR TECHNOLOGY CORPORATION

**Pinger Model:** *Gillnet Pinger*

**Battery:** Replaceable 'D' cell

At the commencement of the duration trial the pingers were attached to the headline of the gill nets using 1.3mm braided nylon twine. The twine was doubled over, to avoid knot slippage, and passed through the attachment holes a number of times to try and minimise compression of the shell material as seen in Phase 1 one of the trial. The twine was then passed through the hole at the end of the pinger. Each end in turn was then tied, through the lay of the headline rope, adjacent to a net float to aid buoyancy and give the pinger some protection from impact damage. The pinger was tied as tightly as possible to avoid negative impacts on the gear and possible button holing. The design of the AIRMAR pingers with holes for attachment at the tips made attachment to the headline as easy as possible. For comparison with other pingers see discussion.

When the batteries of the inoperative pingers were examined it was found that on all 13 batteries the positive terminals had been compressed hence causing a loss of contact. It appeared that this was probably the result of impacts undergone by the pingers whilst being deployed on the net. The 13 inoperative pingers were then tested with a new battery. Seven of the 13 pingers returned a satisfactory signal the remaining 6 returned no signal. On further investigation of the 6 pingers it was found that although the circuitry of these pingers was live the transducer was either disconnected or broken. (These 6 pingers were returned to the manufacturer for further testing.)

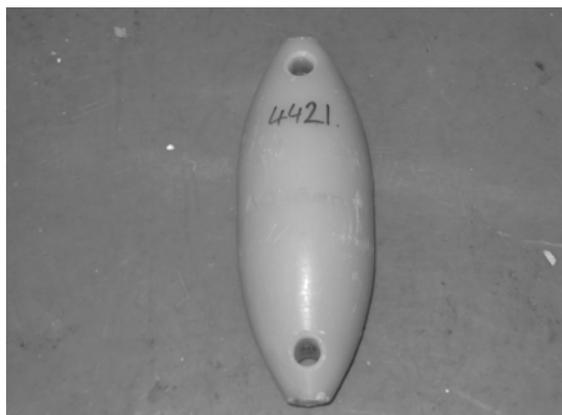
#### AQUATEC GROUP Ltd.

**Pinger Model:** AQUAmark 100

**Battery:** Non-replaceable 'D' cell. Return to manufacturer

At the commencement of the duration trial the pingers were attached to the headline of the gill nets using 1.3mm braided nylon twine. The twine was doubled over, to avoid knot slippage, and passed through the attachment holes at the end of the pinger. Each end in turn was then tied, through the lay of the headline rope, adjacent to a net float to aid buoyancy and give the pinger some protection from impact damage. The pinger was tied as tightly as possible to avoid negative impacts on the gear and possible button holing. The design of the AQUAmark pinger caused slight problems with this method of attachment as the attachment holes are inset from the ends of the pinger. Potentially the ends of the pingers are vulnerable to hitching on the netting.

The faults in the 8 pingers returned to this manufacturer were a direct result of the moulding process carried out to make these pingers. These pingers were constructed in two stages, firstly the circuitry is attached to a pre moulded section of the pinger, and then a second moulding process forms the actual shape of the pinger. The problems with the faulty pingers occurred along the joins between the pre and final mould. The manufacturers consider that they have solved this problem by forming the pinger during a single moulding process. Further developments are expected with the use of epoxy instead of polyurethane for the material of the pinger (see Discussion Section 9.1.3).

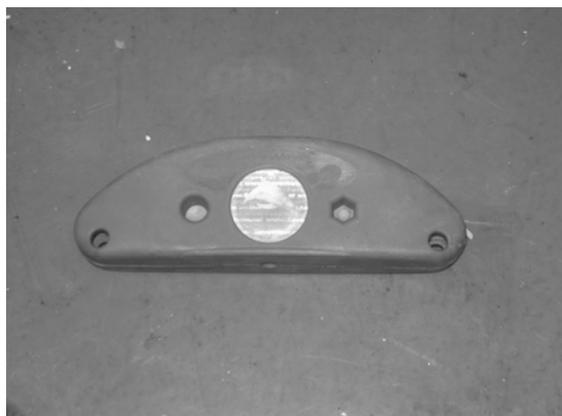
#### **SAVEWAVE INTERNATIONAL**

**Pinger Model:** Endurance Saver

**Battery:** Non-replaceable lithium cell.

The casing of the pingers were examined, all 9 casings were found to be slightly misaligned, in addition 6 of the 9 pingers had loose fixings inside the casing allowing the battery/electronic inserts to move.
