Kingfisher Fortnightly Bulletin

Subsea Cables Subsea Cables Subsea Cables

6th January 2011

Issue 01 / 2011

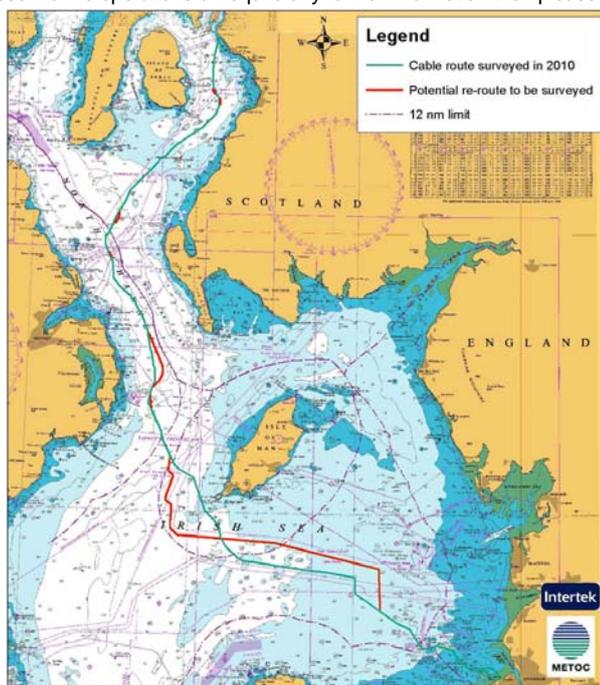
Red sections indicate potential re-route, and therefore, additional survey activity.

Fishermen are advised not to leave any static fishing equipment within a distance of 1000 metres of the route and vessels are requested to keep beyond a distance of at least 1 nautical mile from the survey vessel that will be operating with towed equipment and will have restricted manoeuvrability. If you think you are likely to be affected by these marine operations or require any further information then please contact Colin Richards (details below).
