Marine Accident Investigation Branch
First Floor, Spring Place, 105 Commercial Road
Southampton, United Kingdom
SO15 1GH

June 2018

MAIB ANNUAL REPORT 2017

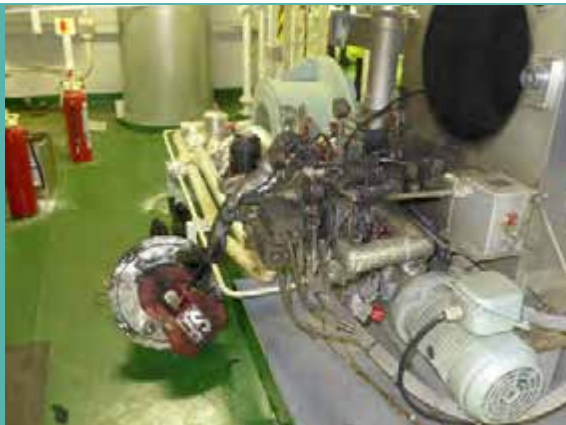
- ▶ Maintenance management; faulty igniter and leaking solenoid valve found during evidence collection
- ▶ Inappropriate fuel resulted in waxing under cold conditions
- ▶ Limited knowledge of boiler fuel/control system resulted in repetitive use of reset function
- ▶ Failure of burner locking arrangement

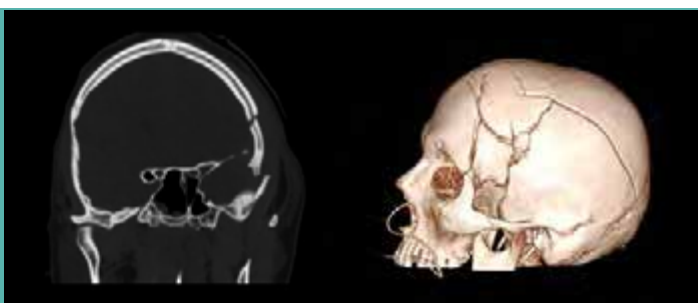
- ▶ Guiding-on pole for trawl net failed under transverse load
- ▶ Crewman was standing in hazardous area

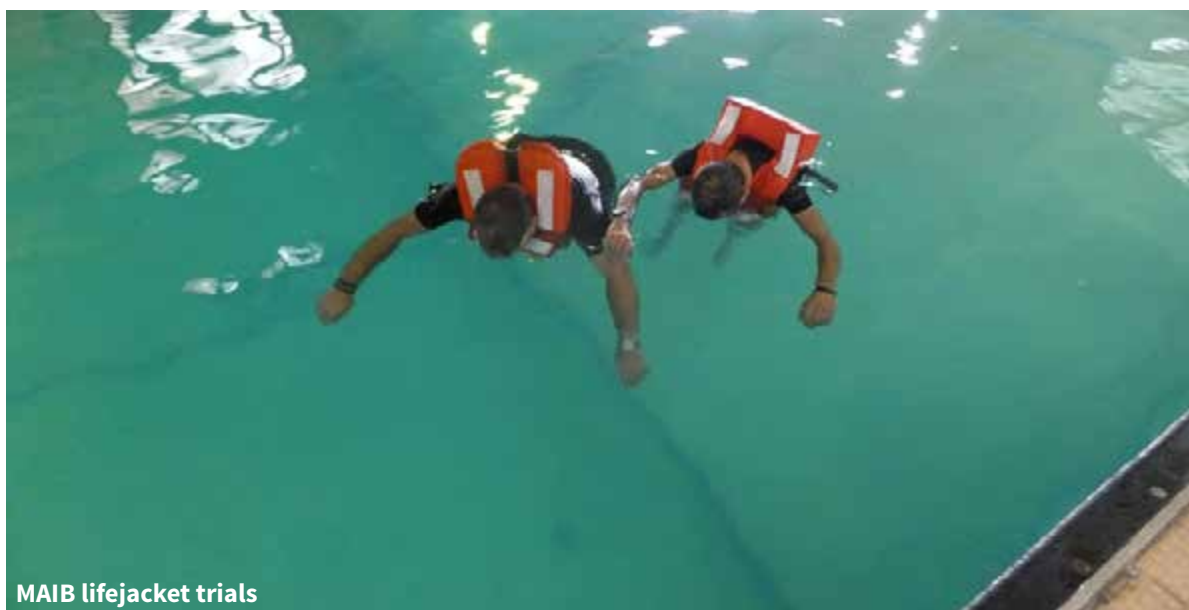
MAIB lifejacket trials

No	Recommendation(s) to:	Maritime and Coastguard Agency
130	Urgently conduct research to confirm or otherwise the effectiveness of SOLAS lifejacket water performance test requirements to ensure approved lifejackets will satisfactorily turn a face-down, unconscious person onto their back with sufficient orientation and buoyancy to maintain their airway clear of the water. Any shortcomings in the water performance test requirements that may be identified should be brought to the attention of the International Maritime Organization for action.
